# N830EH

## Aircraft Build Log

| Kit Model: | Sonex B (A Model Conversion) |
| Kit Serial: | 0849B |

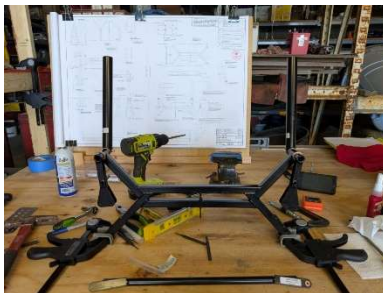
Set bushings into top of control stick frame with Loctite 638. Using new taper reamer, reamed LH stick grip hole and inserted taper pin. Repeated whole process for right hand stick grip and found that sticks were not parallel with control horns and cross link tube would not fit in between left and right control sticks. In order to properly fit link rod, both control sticks would be tilted 5 degrees outward. Suspect that control sticks slightly twisted when initially drilling shafts. Decided to redo control sticks with spare control horns from original kit. Removed powder coating from new control horns and lubricated with white lithium grease. Inserted horns into the control stick frame and squared them up using digital level. Attached link rod to RH horn and drilled 3/16" pilot hole in link rod for LH horn. Enlarged hole and

Bad stick assembly; control sticks not parallel to control horns

installed SF-610-3 bushing into link rod. Rechecked squareness of assembly; checked good. Installed SF-812-3 bushings into lower pivot points of control frame. Realigned LH control horn to vertical position and placed existing control stick onto horn shaft. Clamped control stick to piece of scrap wood to keep it square with assembly. Drilled approximate taper pin hole size on both sides of shaft separately using existing holes in the control stick. Reverified squareness with assembly then finished hole off with (properly sized) taper reamer. Repeated process on RH side using opposite control stick to set vertical position of assembly. Temporarily reinstalled old taper pins to check assembly; both sticks vertical with link rod centered and no play in mechanisms. Will replace taper pins at later date.

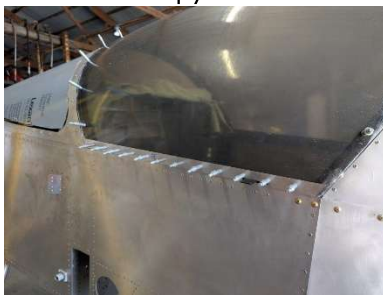
Broken tap in aft canopy frame

Spent most of the time getting the broken off tap out of the canopy frame. Tried to remove it with cutting fluid, heat, and punches but would not budge. Ended up purchasing two solid carbide drill bits and slowly drilling out the tap. Boogered up the hole a bit in the process but the canopy frame should still

be useable; will plan on using longer 6-32 screw and small nut on the inside. Finished tapping the rest of the canopy frame holes but using cutting fluid. Will clean heavily before attaching the canopy.

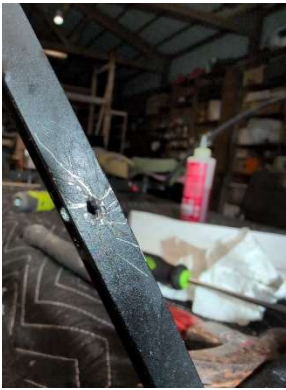
Tap mostly drilled out

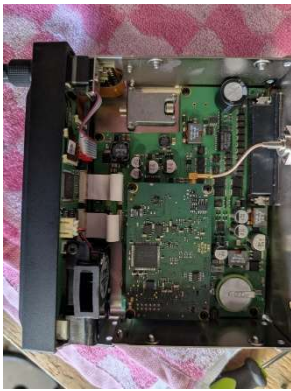
GPS 175 guts

Diagnosed GPS175 screen issue by disassembling unit and cleaning and reseating screen ribbon connectors; ops check good. Installed GPS harness onto back of tray and wired-up ground and power connections. Installed unit and tested; ops check good. Fabricated antenna cable from RG400 coax and drilled center holes for both Dynon and Garmin GPS antennas. Spaced center of antennas 9 inches apart per Garmin recommendation. Temporarily installed Garmin antenna and tested; checked good. Extended Dynon display harness for SV-GPS-250 with wire splices and ran wires along RH side of fuselage to baggage compartment. Installed DT connectors on antenna and display harness. Still need to mount antennas so will leave runs long for now. Located OAT probe under RH side of horizontal stabilizer and ran wires along with ELT remote harness along RH side of aft fuselage.

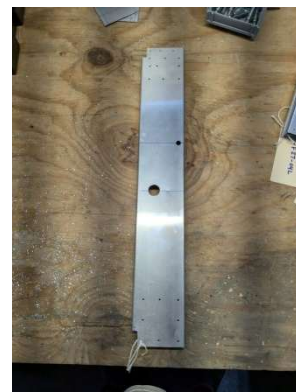
-02L complete. -02R needs  
replacement

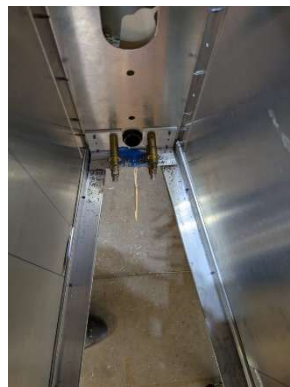
Replaced F23-02 and -03 aft  
bulkhead and lower angle and  
updrilled tail wheel mount  
holes to  $3/16"$

Replaced F23-02 aft bulkhead and F23-03 forward lower mount angle with new parts and drilled  $3/16"$  holes for tailwheel mount. Located aft fuselage tail channel on rear of tail cone and pilot drilled and clecoed into place. Secured F23-04 aft lower mount angle against longerons and rear channel and drilled holes for AN3 hardware through tailwheel mount. Lower holes ended up a little close to horizontal part of mount so took grinder to flatten the fillet a little bit. Located, pilot drilled, and clecoed aft shear web to longerons, rear angle, and aft bulkhead. Flipped tail cone assembly over and pilot drilled holes in upper longerons for T12-05 tail mount angle. Located, pilot drilled, and clecoed #1 lower cross tie while checking and verifying tail cone spacing and squareness. Finally, located aft fuselage floor on bottom side of assembly and began to pilot drill and cleco floor to lower longerons.

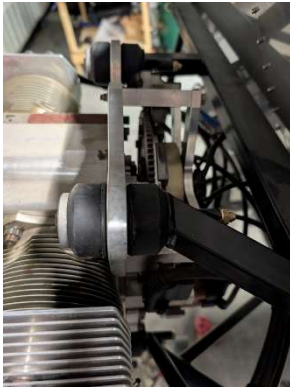
Engine mount hardware replaced with proper size

Replaced temporary engine mount hardware (too long) with properly sized AN4-46A bolts and AN363 nuts.

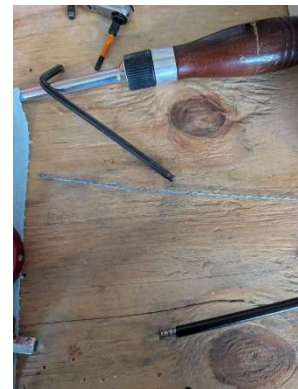
Began process of tuning the AerolInjector. Immediately had issues getting engine started and struggled to keep it idling normally. The partial firing seems to indicate a too-rich condition with the #3 needle. Upon trying to adjust the needle, there were issues trying to turn the needle clockwise to lean the mixture. Decided to remove cowl and AerolInjector for inspection. Upon disassembly, discovered that the needle carrier was not able to be threaded all the way down in the slide. Cleaned out slide threads with a tap and needle was able to be adjusted through the full range. Reassembled AerolInjector and during installation, discovered bellcrank end of throttle cable was frayed and restricting throttle slide movement. Will need to replace.

Throttle cable frayed and  
needs replacement

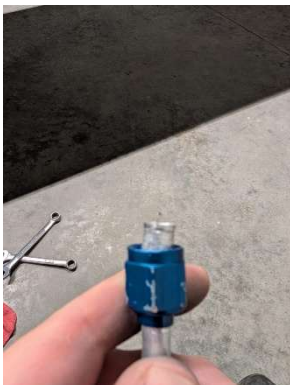
Added fuel to tank in order to test firewall forward side of fuel system. Upon opening fuel shutoff valve, discovered that hardline to system drain was leaking from both AN fittings. Upon removing the line, discovered that the flare fittings were not made properly. Remade hard line and installed new fittings. Leak checked firewall forward portion of fuel system; ops check good after tightening a few lines. Installed SkyBolt hardware onto fuel door and removed Southco fastener from windshield skirt to install SkyBolt receptacle. Worked on vent line by drilling hole in forward fuselage floor just outside of the front left motor mount. Bent a hard vent line from spare steel brake line and installed it to the left main gear leg with zip ties temporarily; will secure better in the future once gear leg fairing is fitted. Cut rubber vent line in cockpit and installed it onto the hard line using a hose clamp. Secured fuel vent on LH forward fuselage wall to keep it from interfering with the LH rudder pedal.

Improper flare on old fuel line

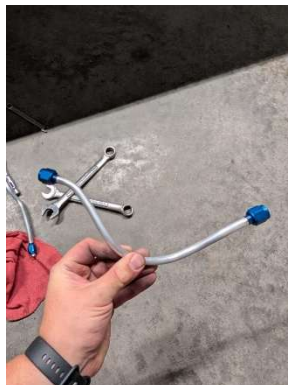
New fuel line cut and bent

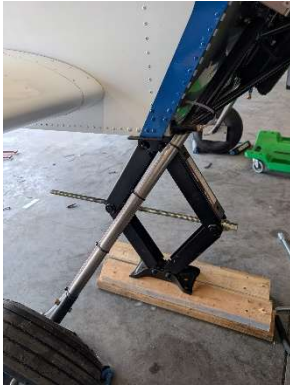
RH gear bolts replaced with  
NAS bolts

Completed Sonex service bulletin SNX-SB-015 by replacing AN hardware in both gear legs with NAS hardware specified in service bulleting. Snugged all bolts then backed off nuts 1/4 turn before applying torque seal.

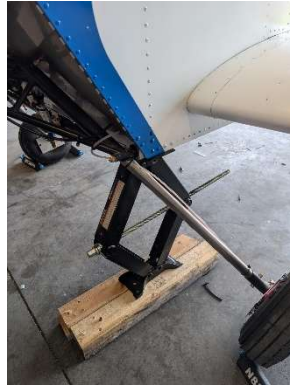
LH gear bolts replaced with  
NAS bolts

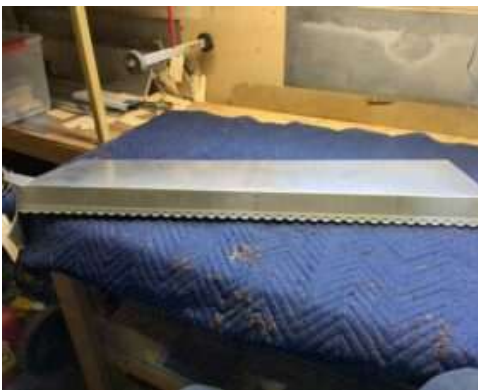
Removed rudder from vertical tail assembly to inventory parts and inspect via camera. Determined that rudder is twisted and will need to replace skin.

Existing rudder

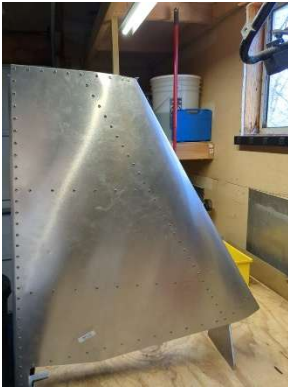
Inspection of vertical stabilizer skin. Holes and fit look to be good. Slight damage notated on front right lower edge of stabilizer.

RH side of vertical stabilizer

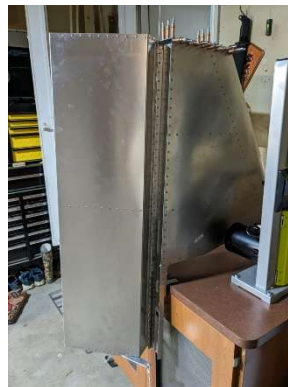
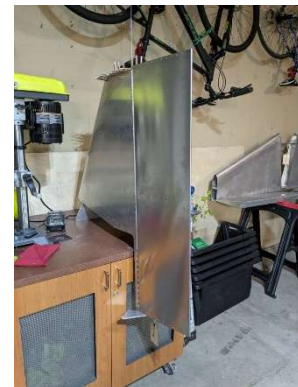
Completed assembly of the rudder including final drilling and riveting. Discovered Hinge Half on vertical stabilizer is misaligned and will need to be replaced and refitted

Noted rudder misalignment

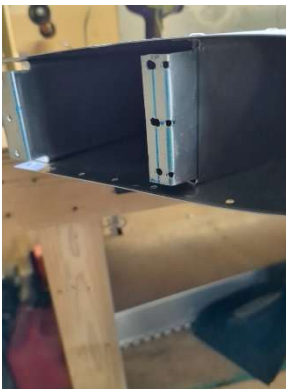
Inspection of previous work and removal of tip ribs for surface tip installation. Hole issues found in forward Spar and tip Rib. Will need to replace rib tip and create doubler for spar

Hole issues in tip rib

Creation of doubler to account for edge violations in forward Spar. Decided that drilling out and replacing forward Spar would be too much work so created doubler to go on back side

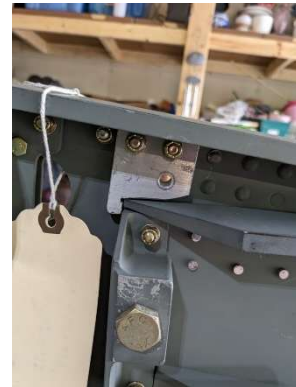
Rig plate missing oversized bolt

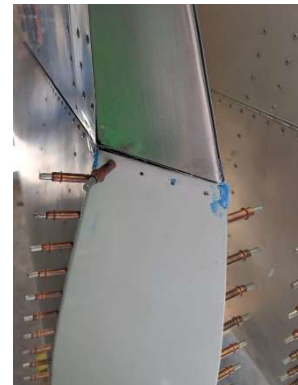
SuperFil being applied to damaged fiberglass

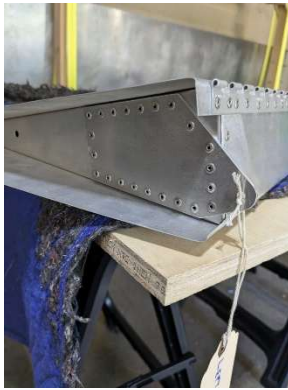
Began flap details by examining already assembled flaps. Flap drive plate needs to be replaced per wing conversion instructions. Upon removing legacy version flap drive plate, noticed holes do not line

Legacy flap drive plate

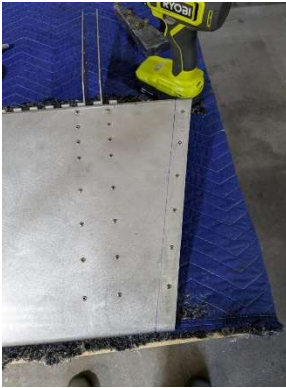
Inspected previously assembled ailerons. Noted that the overall width of existing ailerons is larger than plans called for. Drilled out rivets in tip rib and trimmed skin to proper dimensions. Removed lead counterweights from ailerons and tested fit with wings. Noticed that aileron piano hinges are installed incorrectly and will likely need to be replaced.

Top side of aileron with trim line

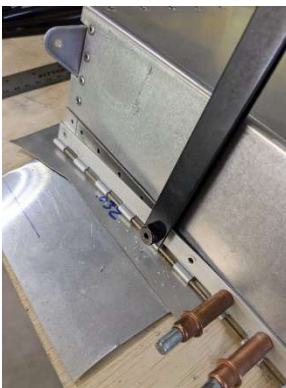
Examined RH aileron assembly. Determined that aileron hinge half was not to plan and was improperly aligned with top edge. Drilled out hinge half and replaced with new hinge using strap duplicator to match holes. Levelled assembly on work bench and finished riveting on counterweight supports. Partially completed aileron assembled to wing and checked freedom of movement: 11 degrees down and 19.5 degrees up movement

Redrilling hinge half with strap duplicator

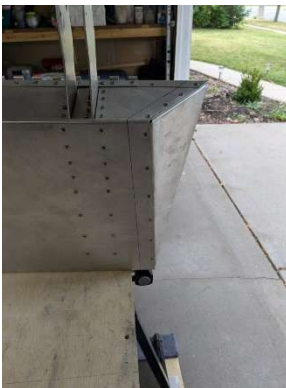
Inventory of existing LH aileron assembly. As noted with RH aileron, skin trimmed slightly longer than specified in plans. Drilled out existing LH aileron tip rib and marked and trimmed LH aileron skin. Two rivets found missing from -06L hinge half and finished in place. LH aileron skin then prepped and deburred for new tip rib installation.

LH aileron skin trim line (lower)
